**JOHNSON CONTROLS, INC.
FOWLERVILLE, MI
EPA ID NO. MID099124299**

**FIELD OVERSIGHT REPORT
FOR PHASE III RFI FIELD ACTIVITIES**

FIELD OVERSIGHT REPORT
FOR PHASE III RFI FIELD ACTIVITIES

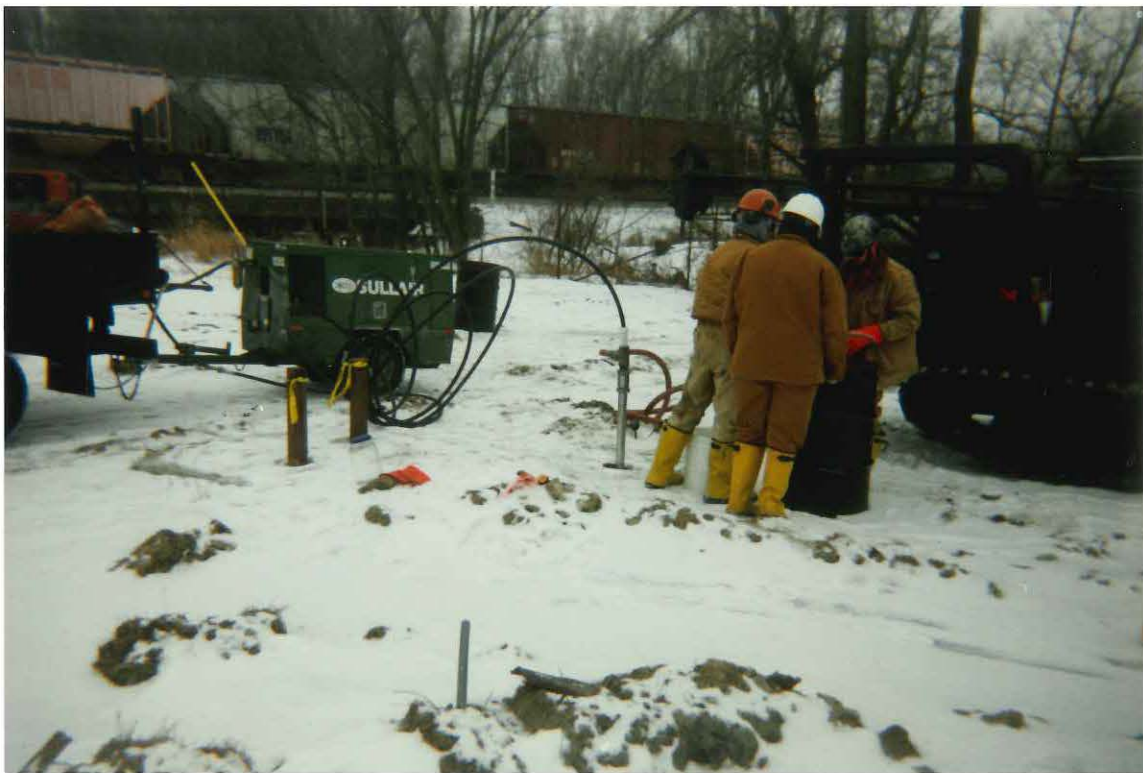
PHOTOGRAPH #64

LOCATION:	Stanley Tools, Fowlerville, MI
DATE:	2/2/94
TIME:	1520
SUBJECT:	Air surging MW-C3.

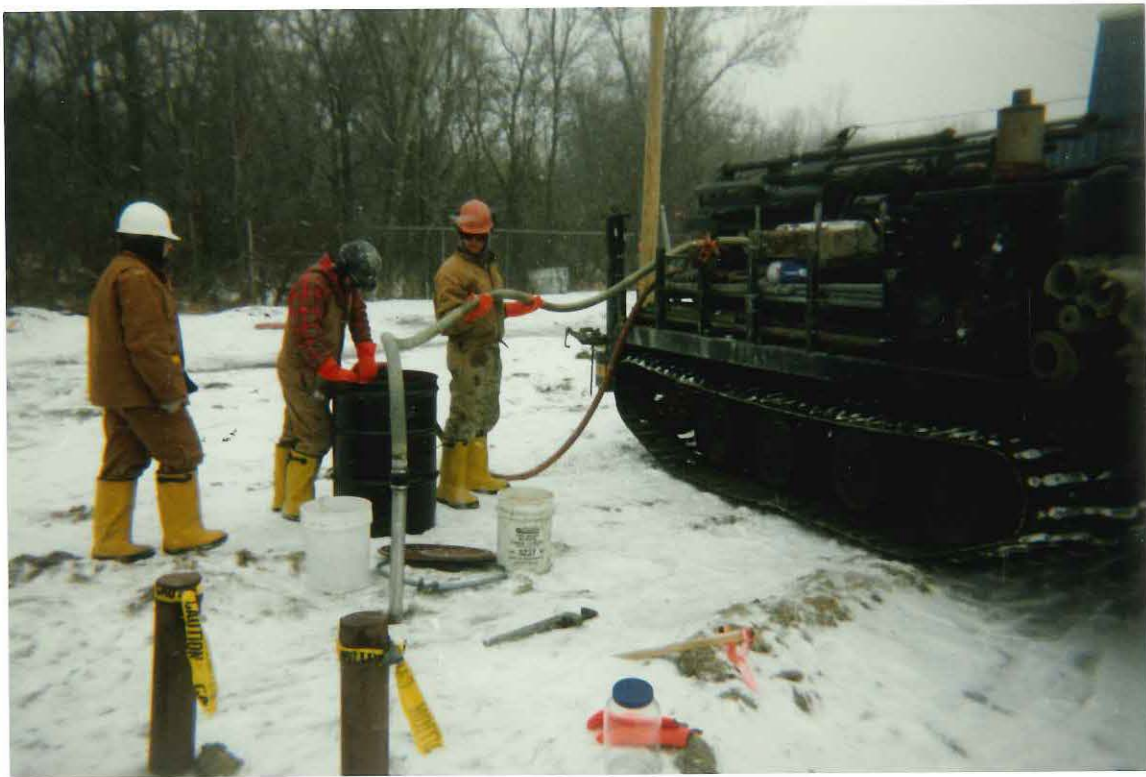
PHOTOGRAPH #65

Stanley Tools, Fowlerville, MI
2/2/94
1540
Development of MW-C3 using the Moyno pump.

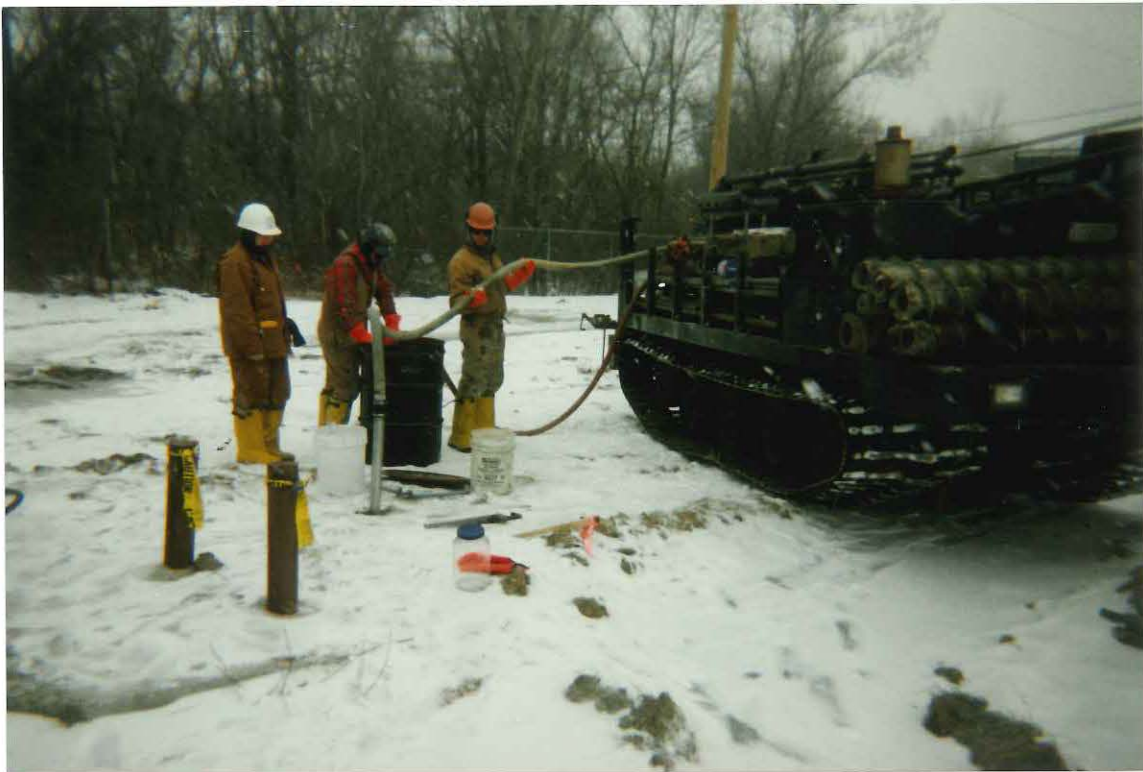
PHOTOGRAPH #66

Stanley Tools, Fowlerville, MI
2/2/94
1540
Development using the Moyno pump on MW-C3.

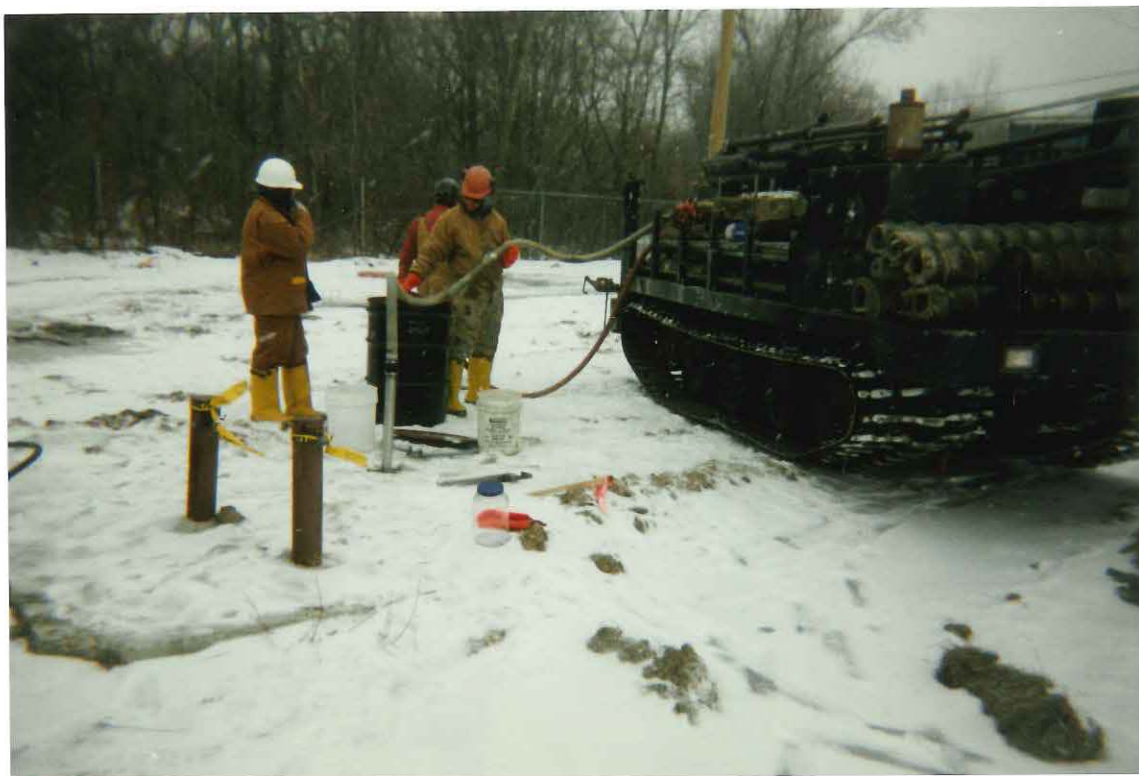
PHOTOGRAPH #67

LOCATION:	Stanley Tools, Fowlerville, MI
DATE:	2/2/94
TIME:	1540
SUBJECT:	Development using Moyno pump on MW-C3.

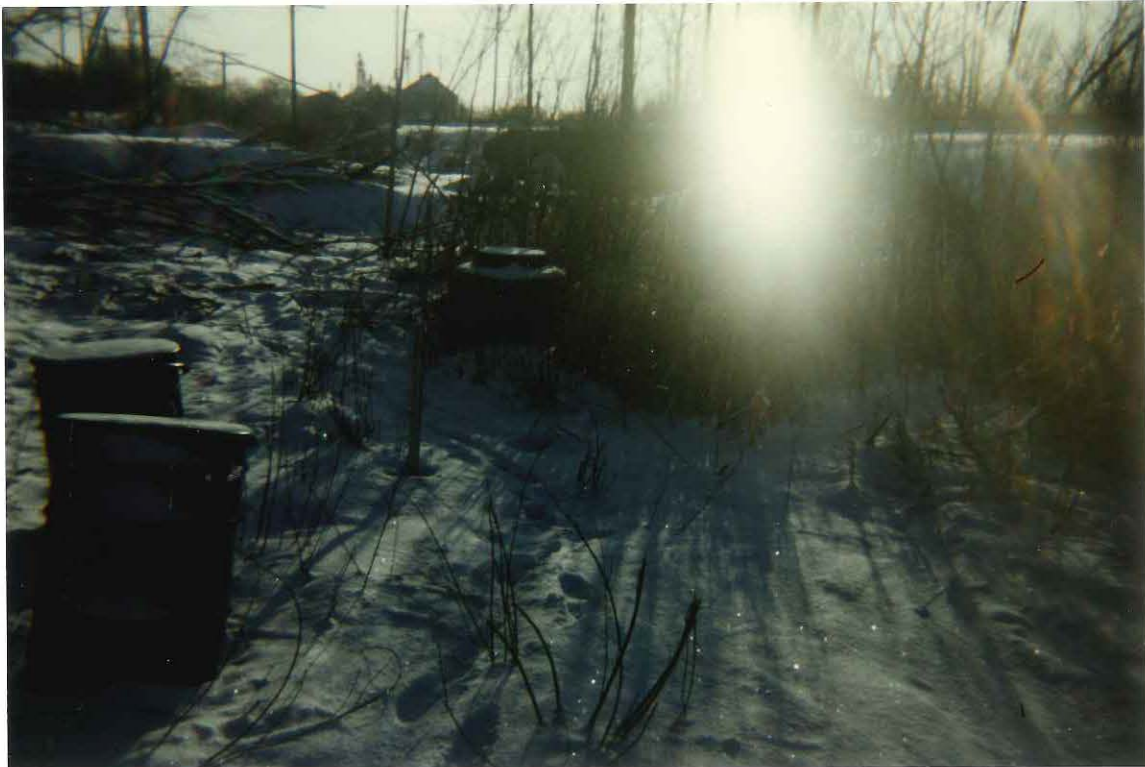
PHOTOGRAPH #68

LOCATION:	Stanley Tools, Fowlerville, MI
DATE:	2/3/94
TIME:	0911
SUBJECT:	Location of MW-OS3.

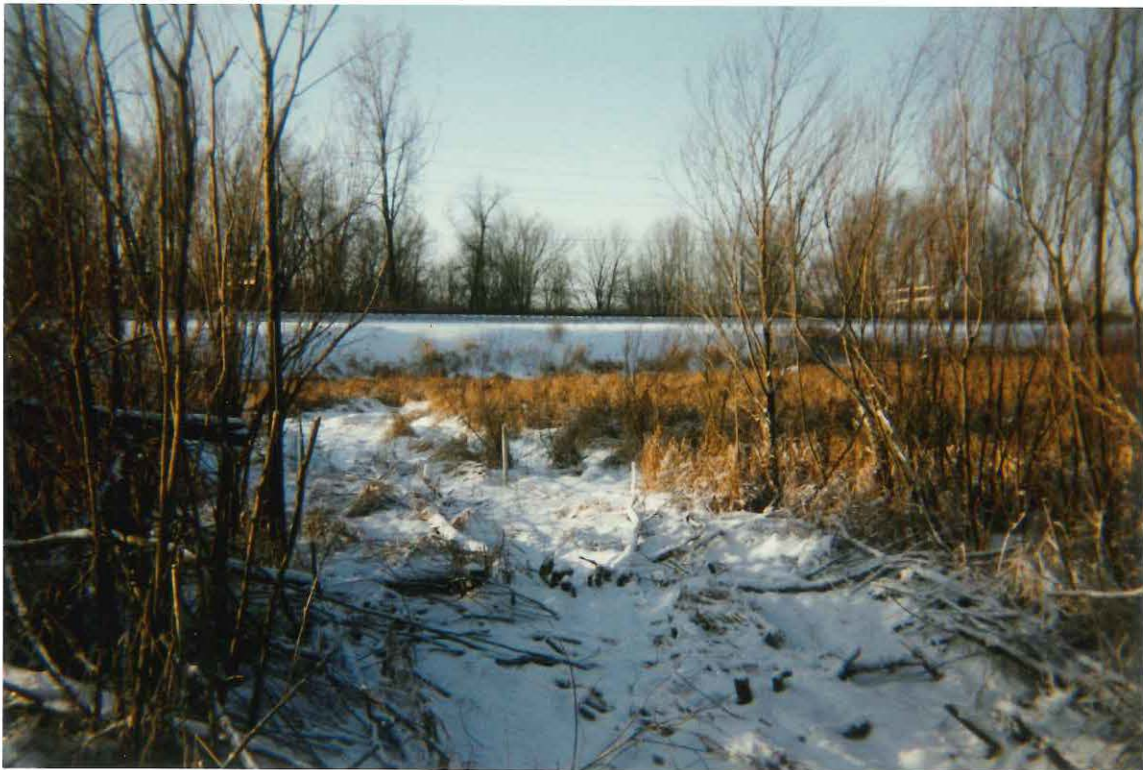
PHOTOGRAPH #69

LOCATION:	Stanley Tools, Fowlerville, MI
DATE:	2/3/94
TIME:	0913
SUBJECT:	Location of MW-OS2.

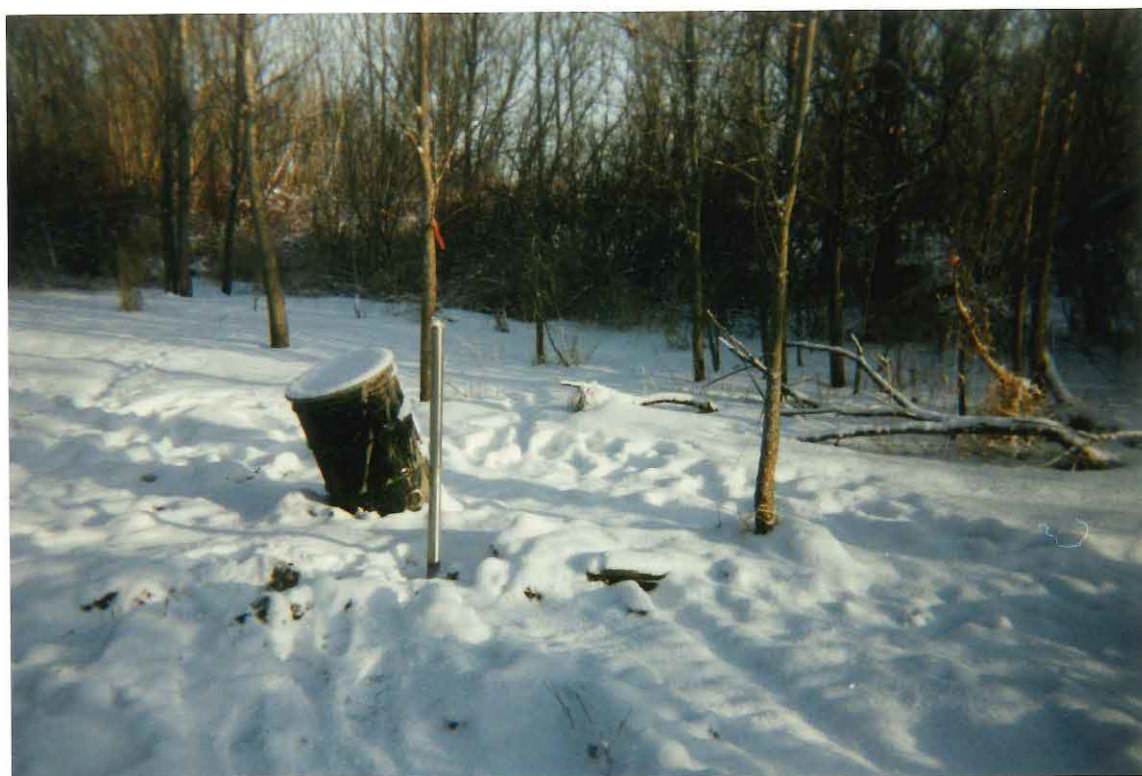
PHOTOGRAPH #70

LOCATION:	Stanley Tools, Fowlerville, MI
DATE:	2/3/94
TIME:	0914
SUBJECT:	Location of MW-OS1.

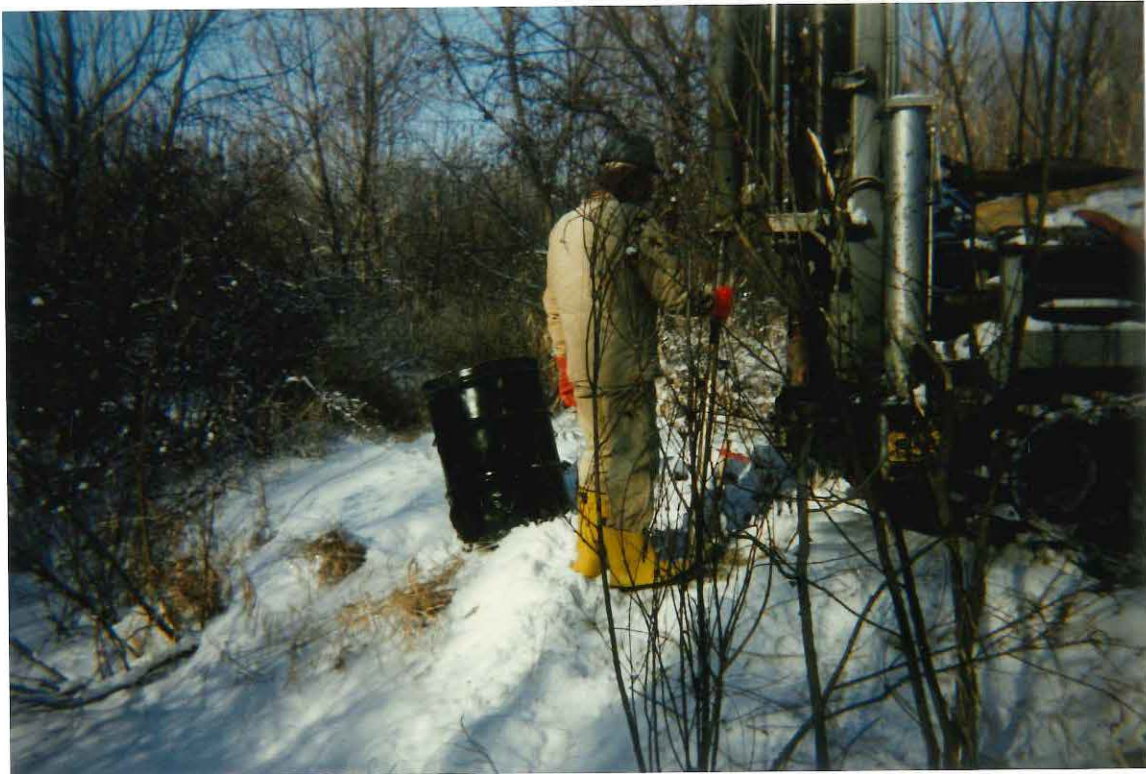
PHOTOGRAPH #71

Location of GB-24. Location is 50' east of Red Cedar River, north of the North Drainage Ditch.

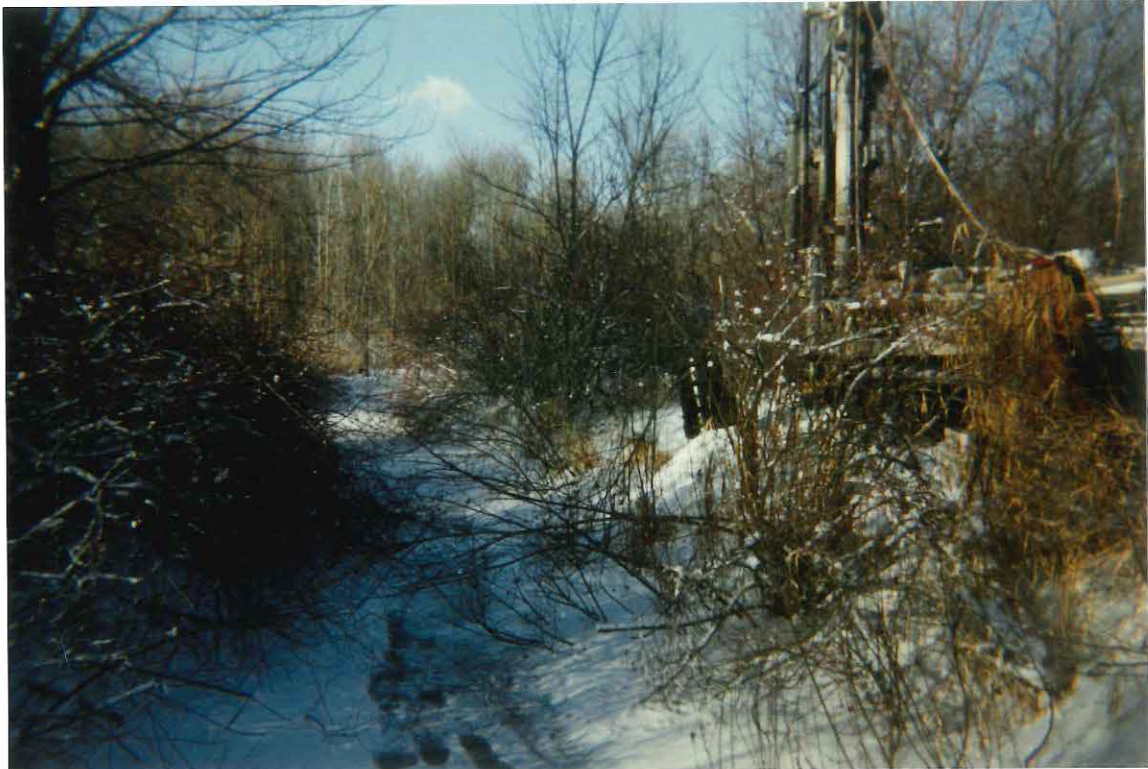
PHOTOGRAPH #72

Location of GB-24. Location is 50' east of Red Cedar River, north of the North Drainage Ditch.

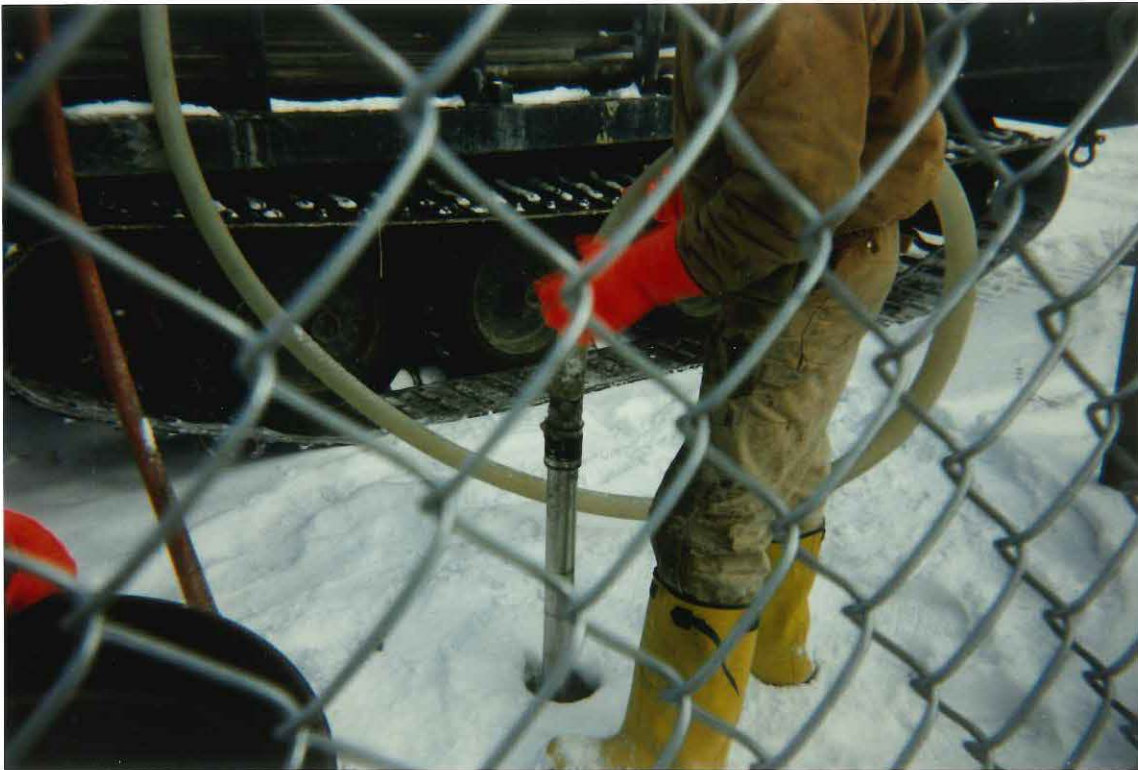
PHOTOGRAPH #73

Location of GB-24. Location is 50' east of the Red Cedar River, north of the North Drainage Ditch.

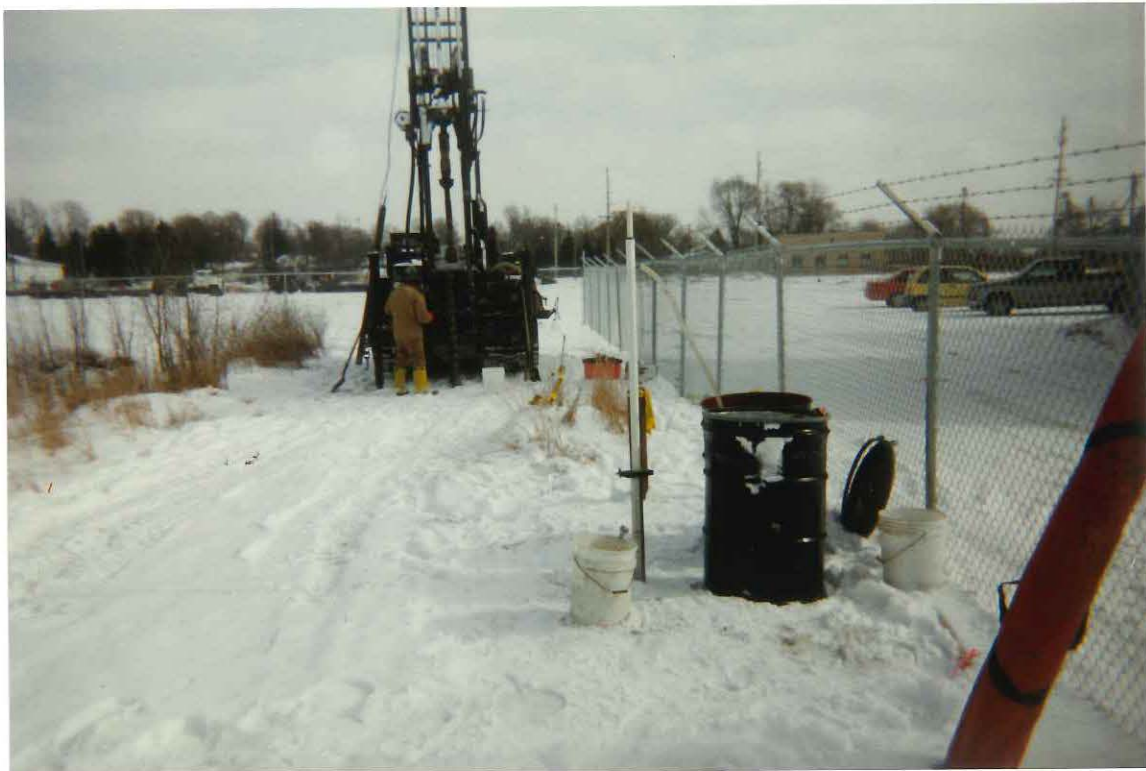
PHOTOGRAPH #74

Stanley Tools, Fowlerville, MI
2/3/94
1152
Trying the Moyno pump on MW-E3; would not work.

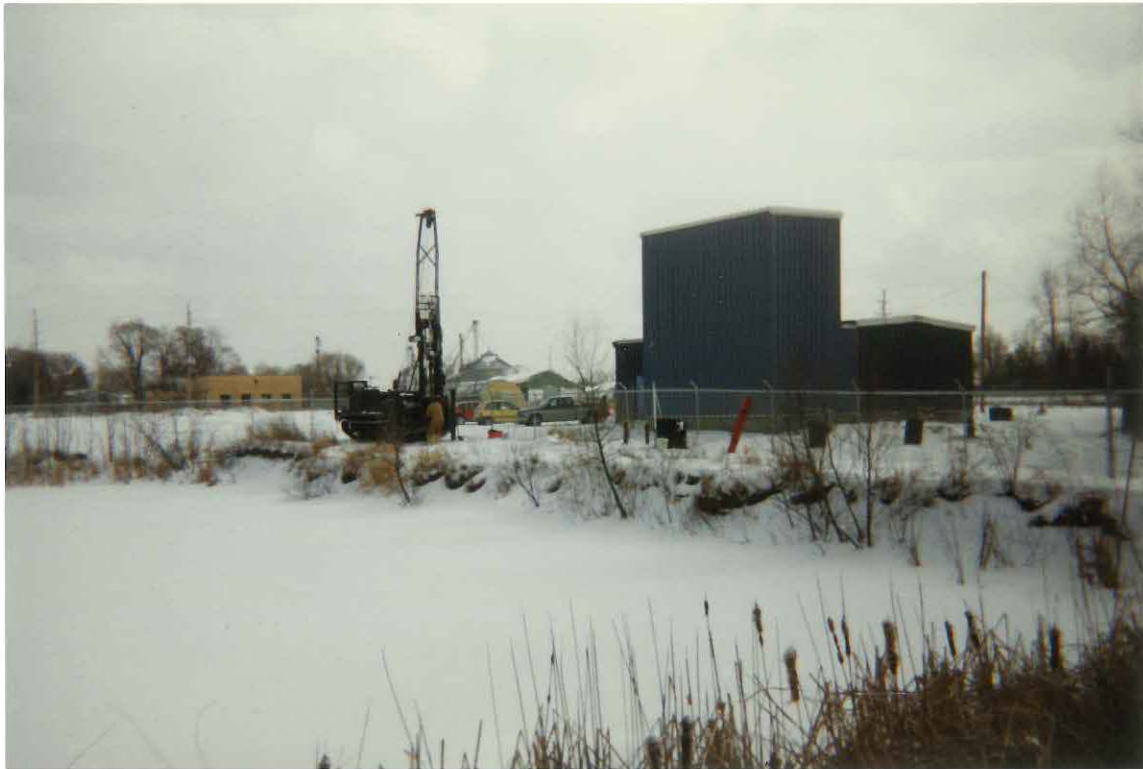
PHOTOGRAPH #75

Well MW-E3 with B-K pump. Setting up on Sludge
Boring E-3.

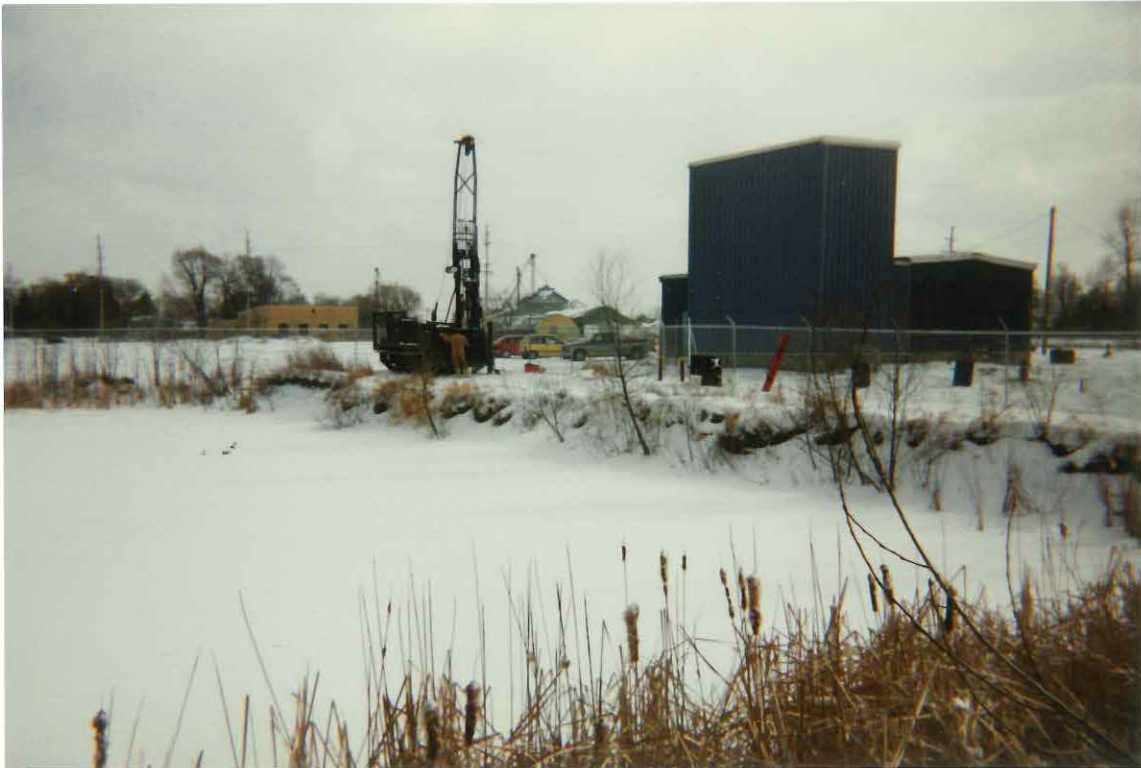
PHOTOGRAPH #76

LOCATION:	Stanley Tools, Fowlerville, MI
DATE:	2/3/94
TIME:	1340
SUBJECT:	Location of Boring E-3.

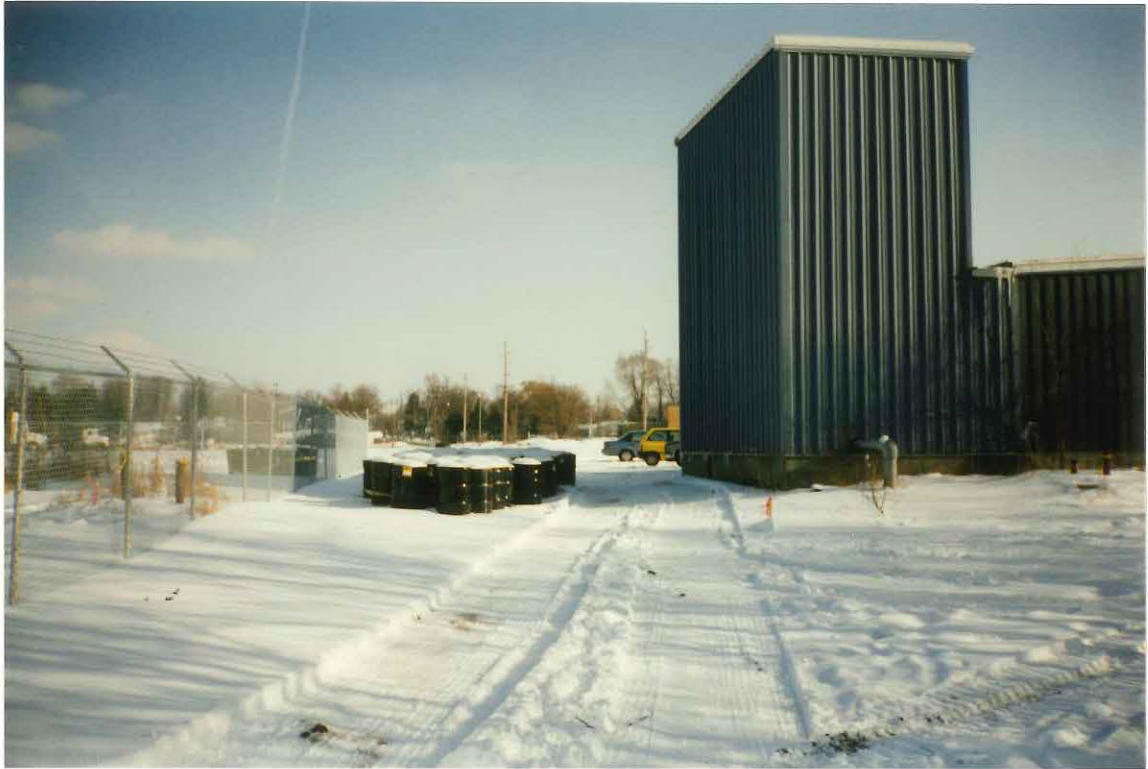
PHOTOGRAPH #4

LOCATION:	Stanley Tools, Fowlerville, MI
DATE:	1/11/94
TIME:	1405
SUBJECT:	Looking east, Waste Treatment Building at Unit J

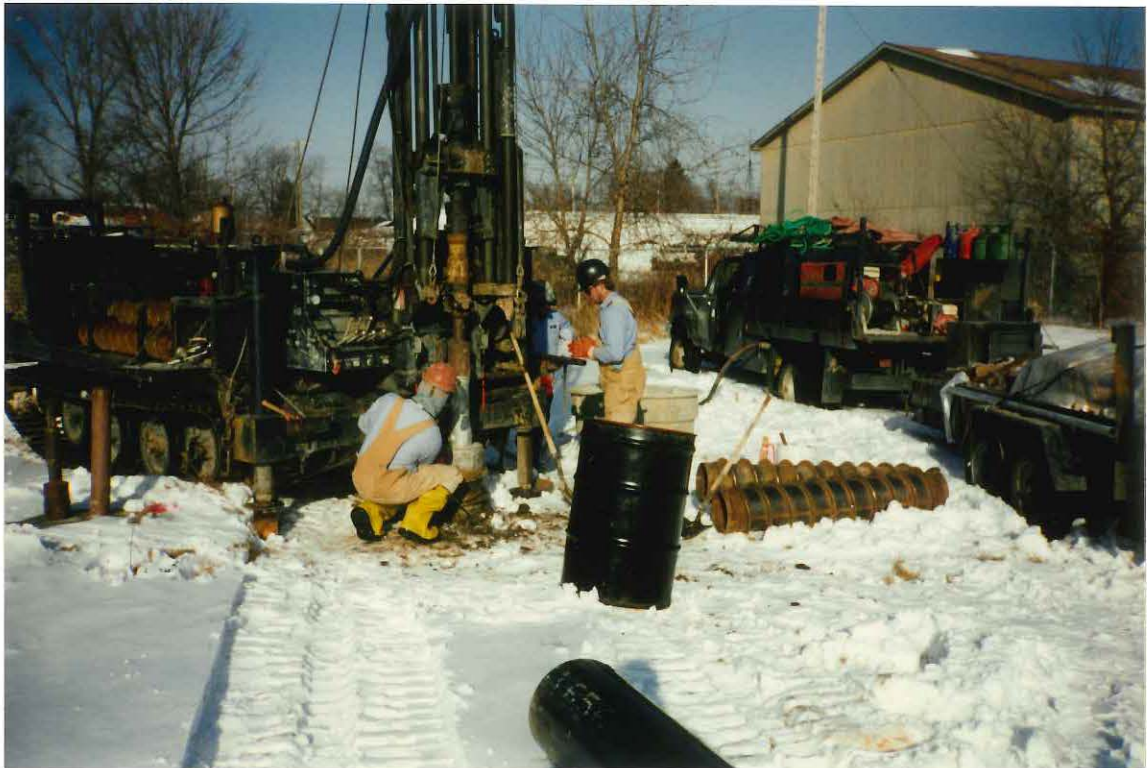
PHOTOGRAPH #7

Augering with 10 $\frac{1}{4}$ " I.D. augers at background well location

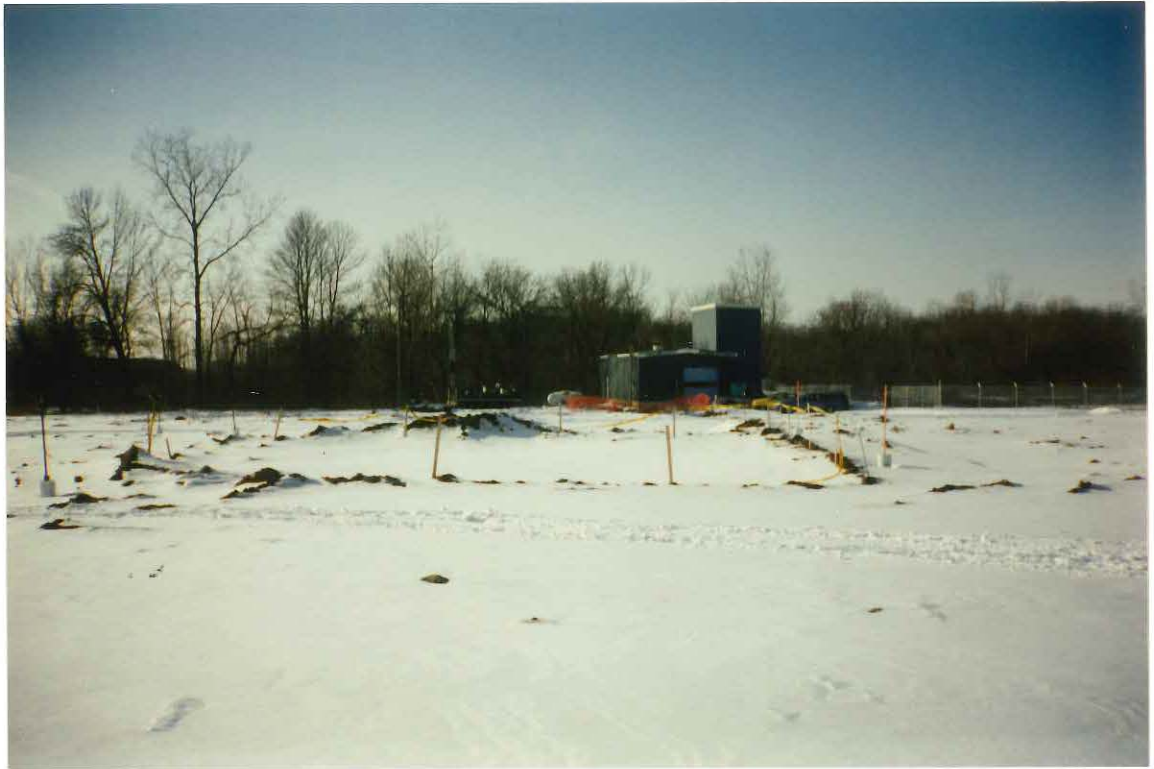
PHOTOGRAPH #10

LOCATION:	Stanley Tools, Fowlerville, MI
DATE:	1/11/94
TIME:	1458
SUBJECT:	Area of chrome recovery under old plant floor

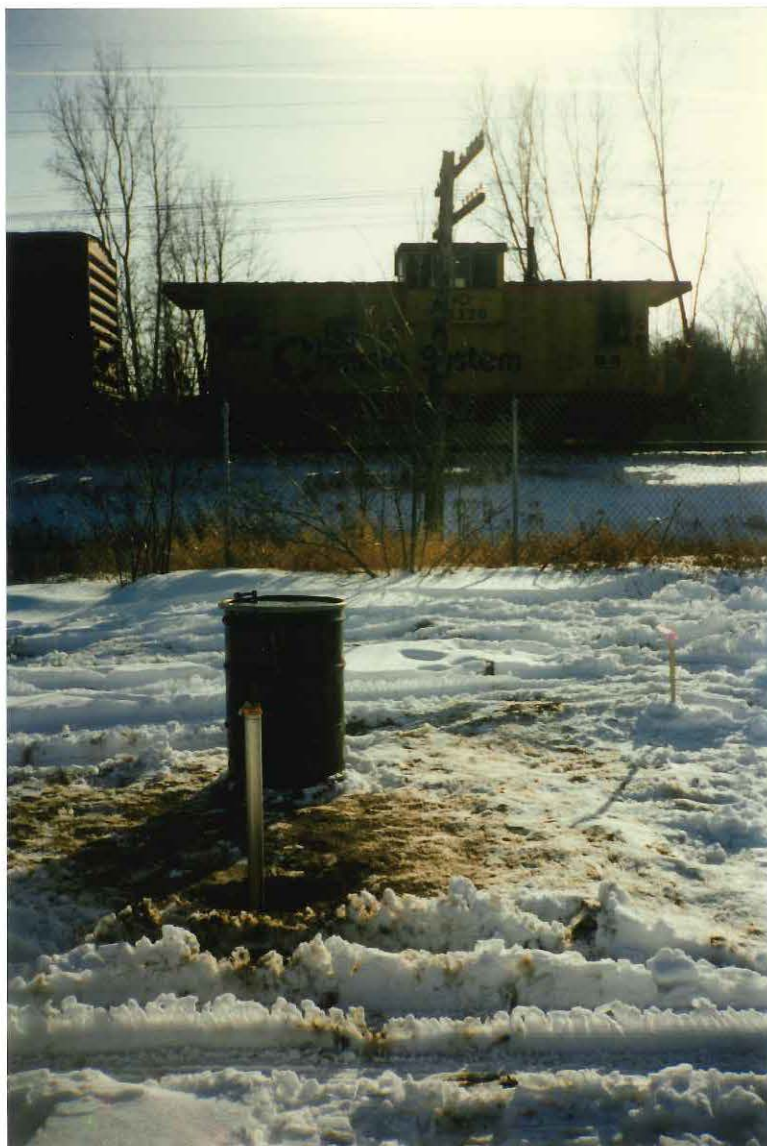
PHOTOGRAPH #11

LOCATION:	Stanley Tools, Fowlerville, MI
DATE:	1/11/94
TIME:	1500
SUBJECT:	Shallow well MW-K1, installed 1/10/94

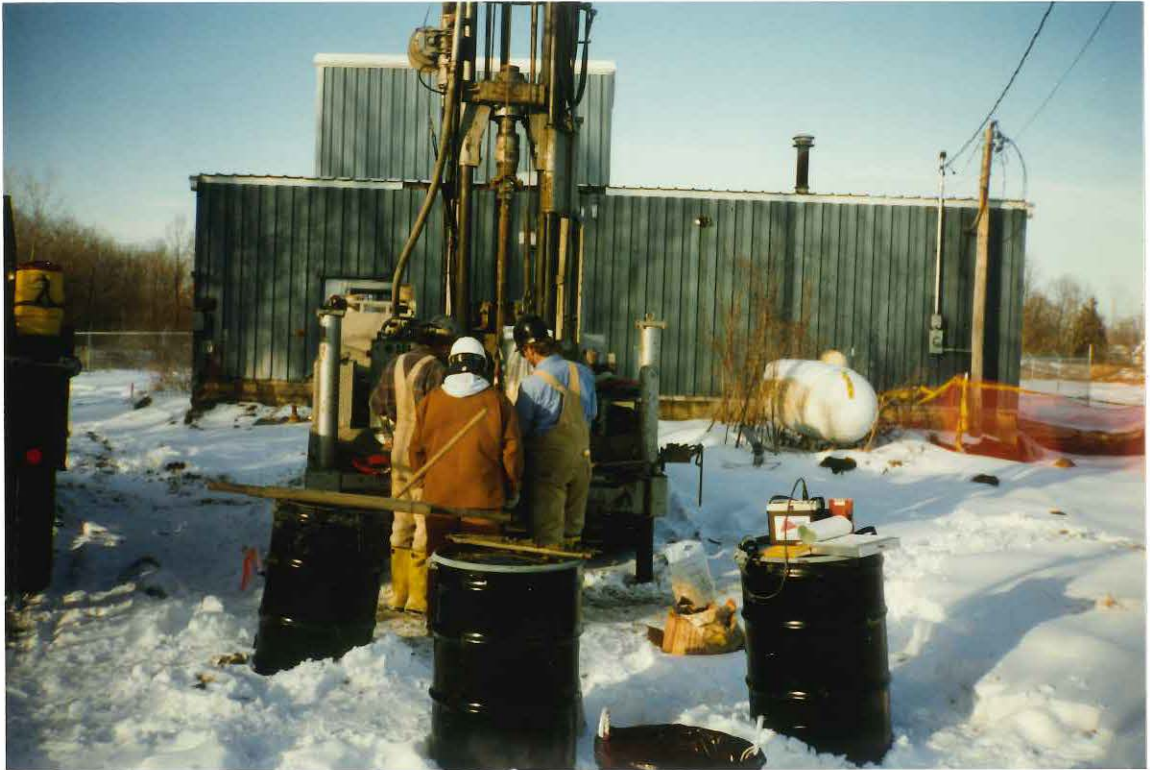
PHOTOGRAPH #12

LOCATION:	Stanley Tools, Fowlerville, MI
DATE:	1/11/94
TIME:	1542
SUBJECT:	Drillers placing sand in shallow well MW-J4

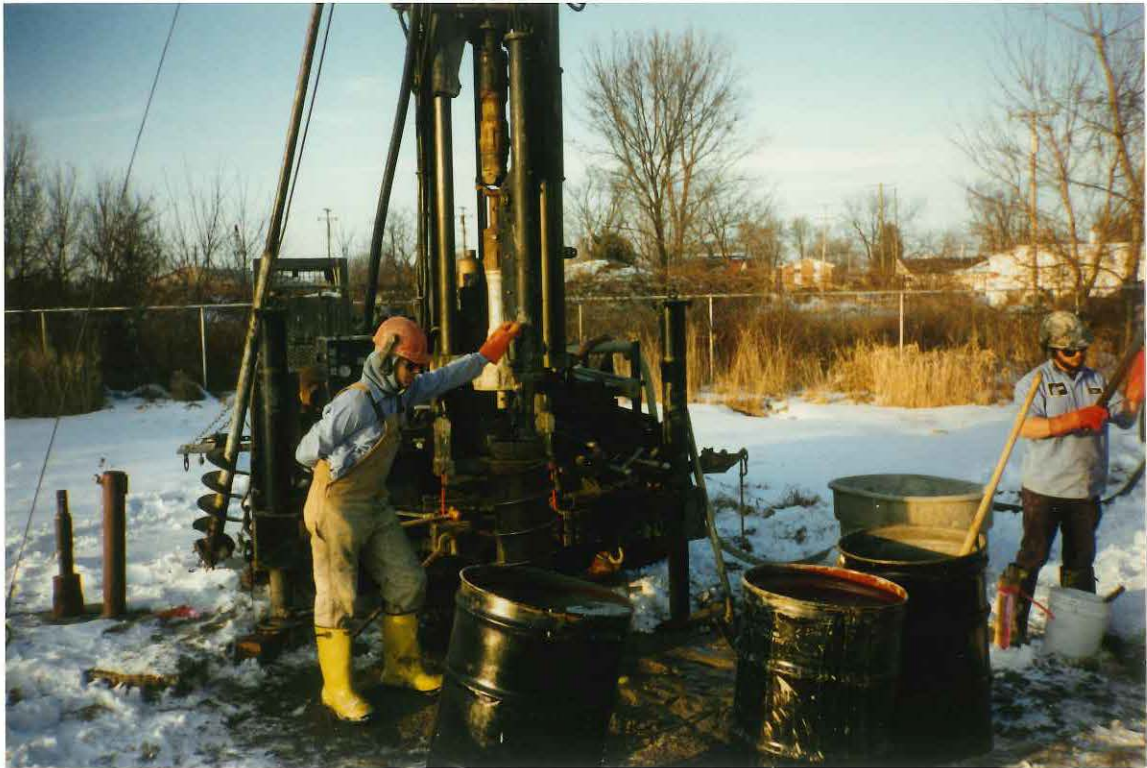
PHOTOGRAPH #13

LOCATION:	Stanley Tools, Fowlerville, MI
DATE:	1/11/94
TIME:	1615
SUBJECT:	Driving split-spoon at intermediate well MW- Background (18-20' interval)

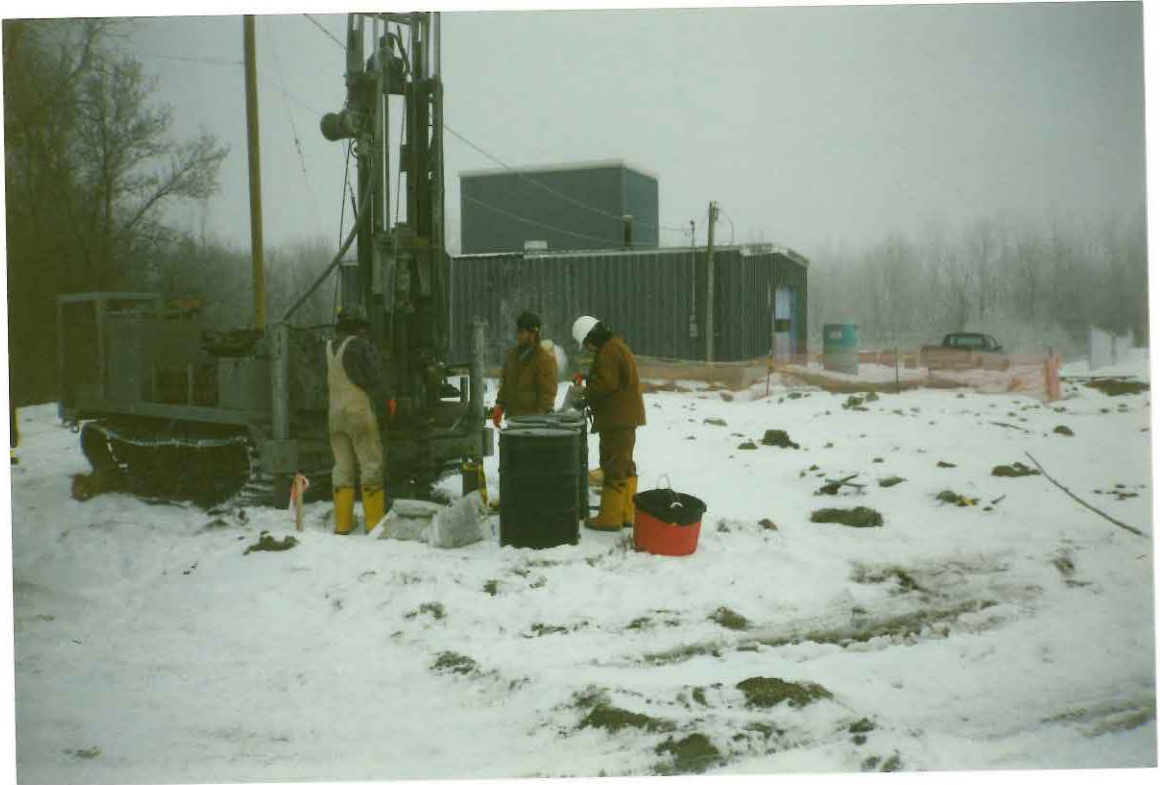
PHOTOGRAPH #14

LOCATION:	Stanley Tools, Fowlerville, MI
DATE:	1/12/94
TIME:	0847
SUBJECT:	Advancing augers at MW-C3 (shallow well)

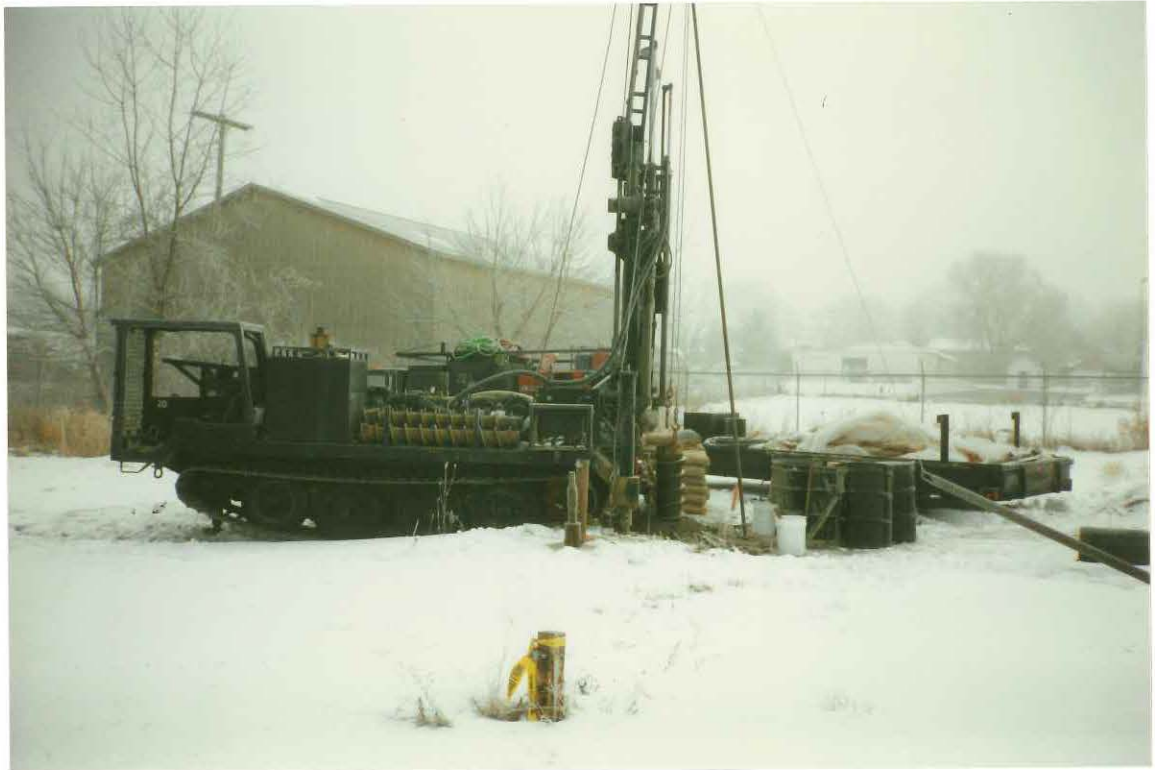
PHOTOGRAPH #15

LOCATION:	Stanley Tools, Fowlerville, MI
DATE:	1/12/94
TIME:	0914
SUBJECT:	Rig at MW-Background

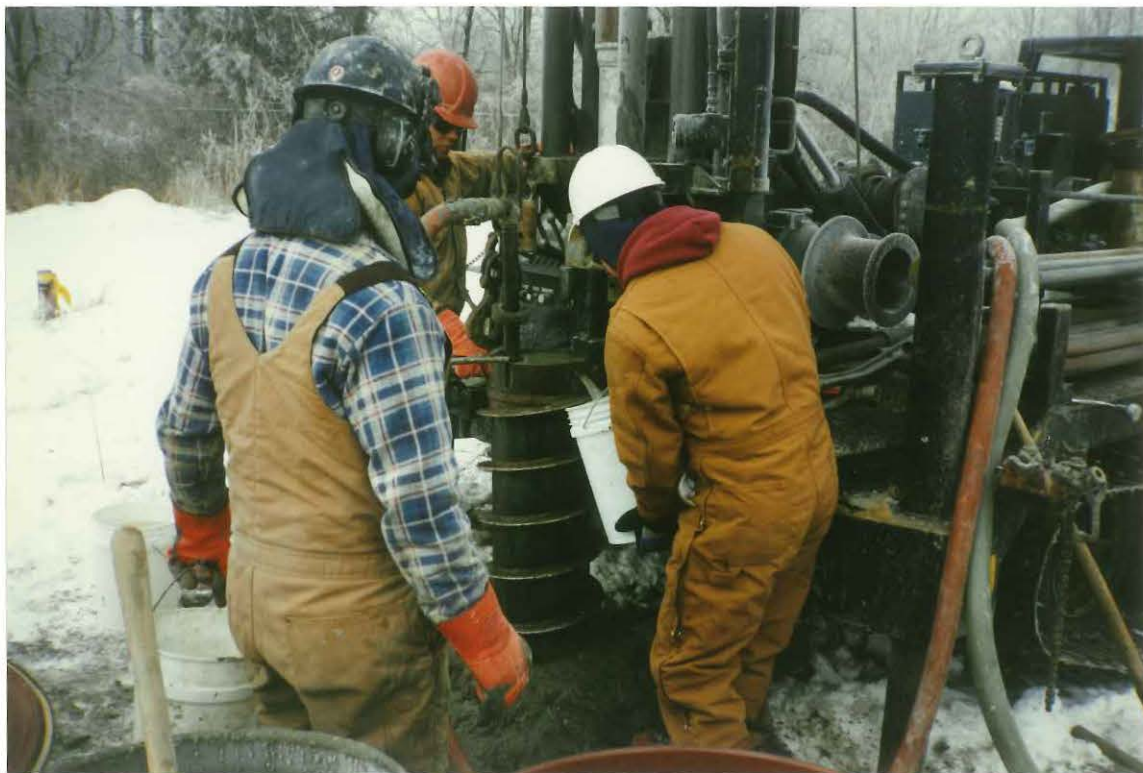
PHOTOGRAPH #16

Stanley Tools, Fowlerville, MI
1/12/94
1012
Catching ground water as grout is being tremied
into MW-Background

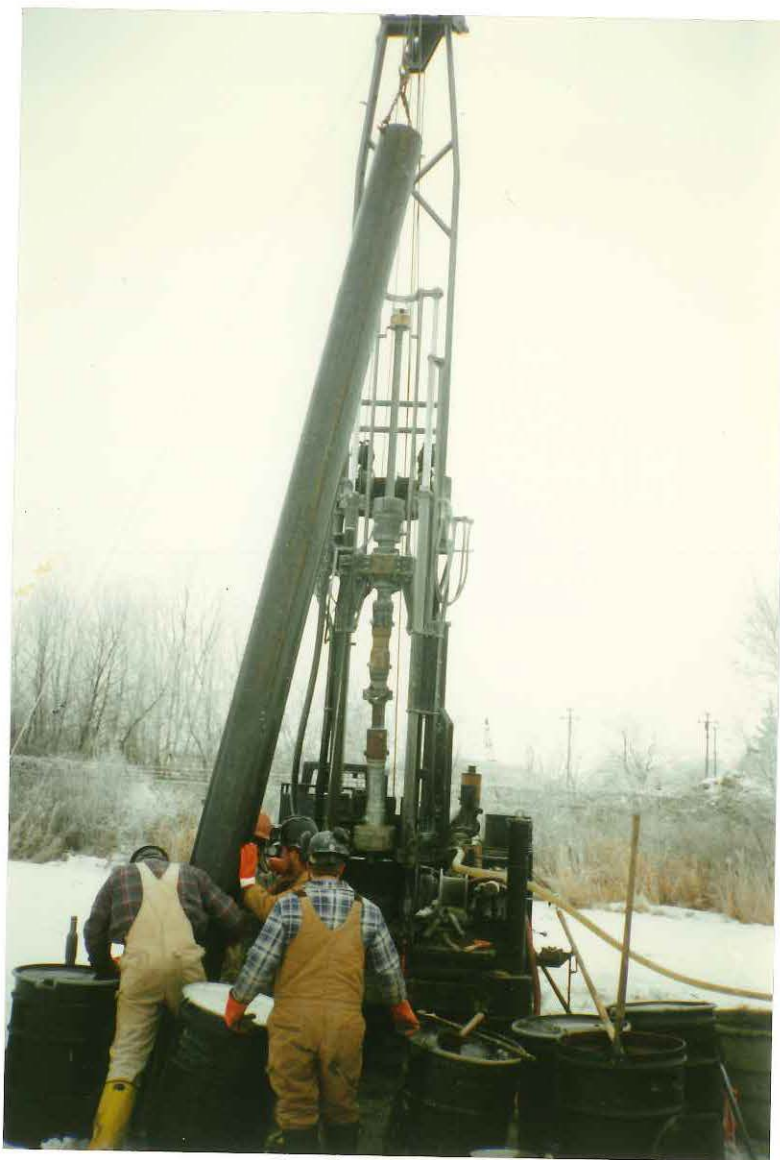
PHOTOGRAPH #17

LOCATION:	Stanley Tools, Fowlerville, MI
DATE:	1/12/94
TIME:	1130
SUBJECT:	Lowering casing at MW-Background

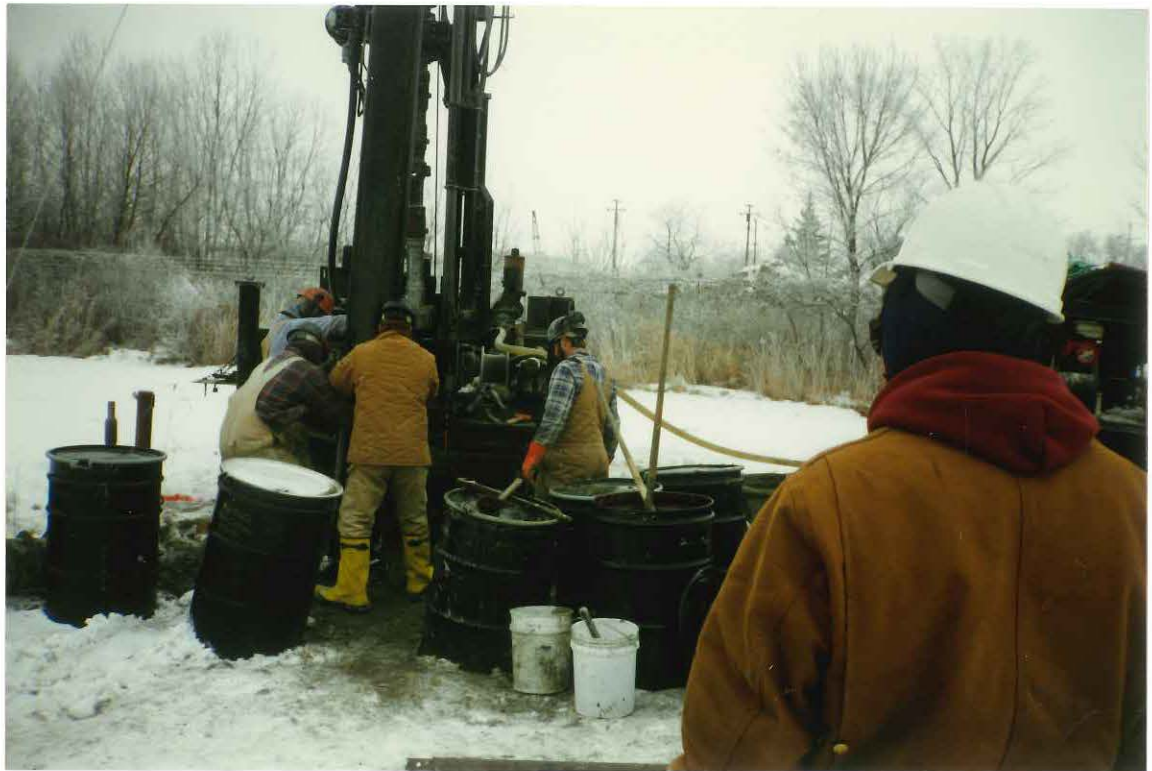
PHOTOGRAPH #18

LOCATION:	Stanley Tools, Fowlerville, MI
DATE:	1/12/94
TIME:	1130
SUBJECT:	Setting casing at MW-Background

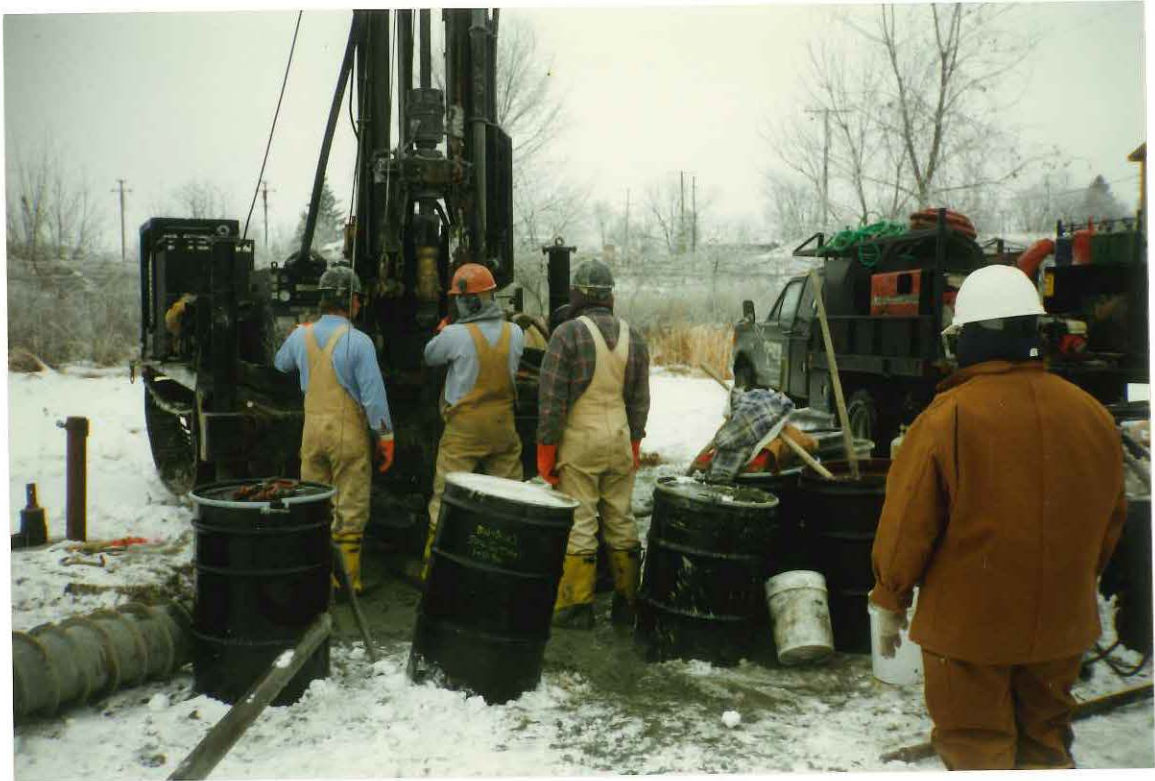
PHOTOGRAPH #19

LOCATION:	Stanley Tools, Fowlerville, MI
DATE:	1/12/94
TIME:	1155
SUBJECT:	Driving casing at MW-Background
